| A | 128/13637 | Window assembly,rear as supplied<br><July 2003<br>Supersession > | 1 |

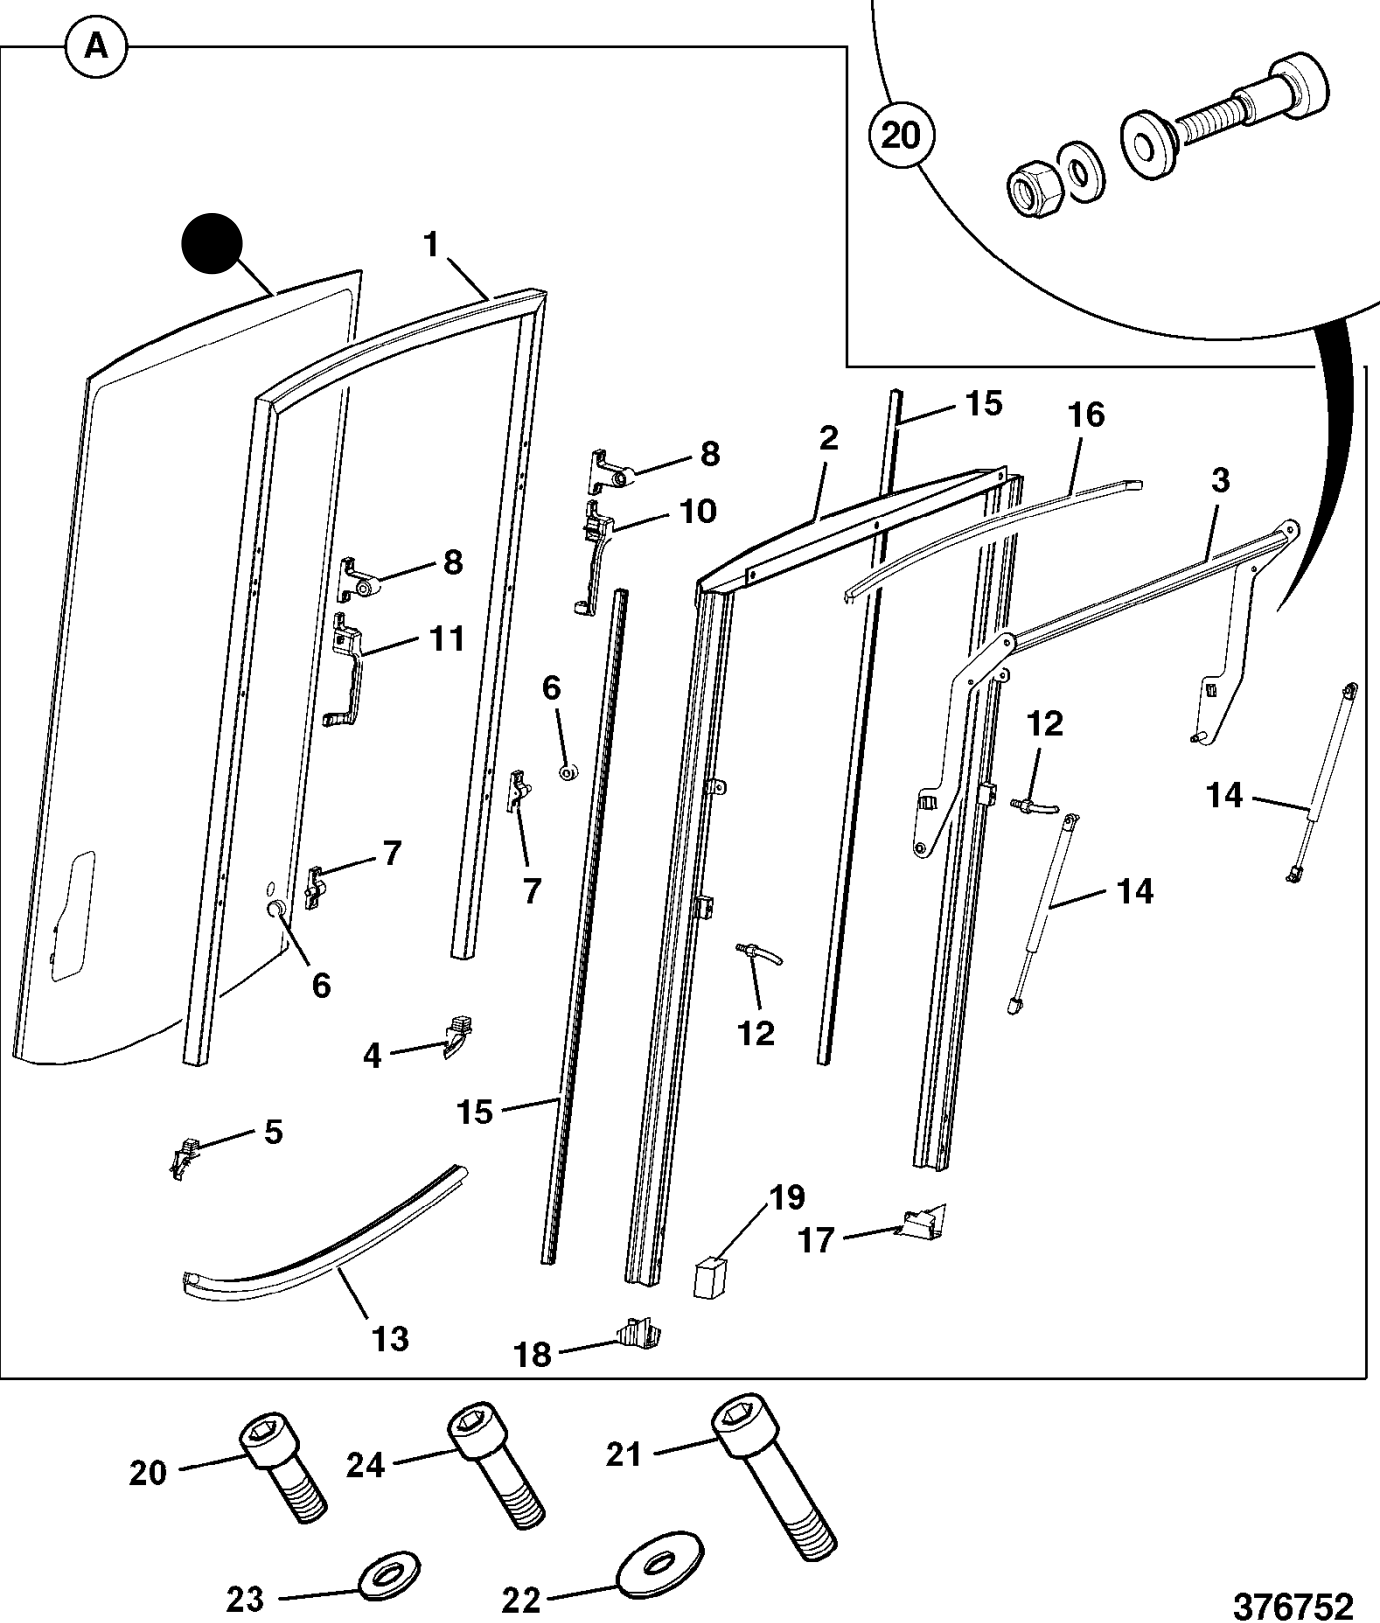
| A | ⊘ Not for sale | Window assembly,rear as supplied<br><M944200<br>Supersession ><br>Left lock bar 75mm higher-to match side glass | 1 |
| 3 | :335/03712 | Bar torsion | 1 |
| 4 | :331/28221 | Seal rear window left hand end | 1 |
| 5 | :331/28222 | Seal rear window right hand end | 1 |
| 6 | :331/28223 | Roller Plastic | 2 |
| 9 | ⊘ Not for sale | Glass rear window<br><M944200<br>> No Longer Available | 1 |
| 10 | :331/28233 | Latch LH | 1 |
| 10A | :331/43562 | Capscrew encapsulated<br>holds 7,8,10 & 11 to frame | 12 |

| 11 | :331/28235 | Latch RH | 1 |
| 12 | :331/28239 | Bar locking<br>Supersession > | 2 |
| 14 | :331/28215 | Strut gas 287 closed, 475 open | 2 |
