| A | 128/13637 | Window assembly,rear as supplied<br><July 2003<br>Supersession > | 1 |

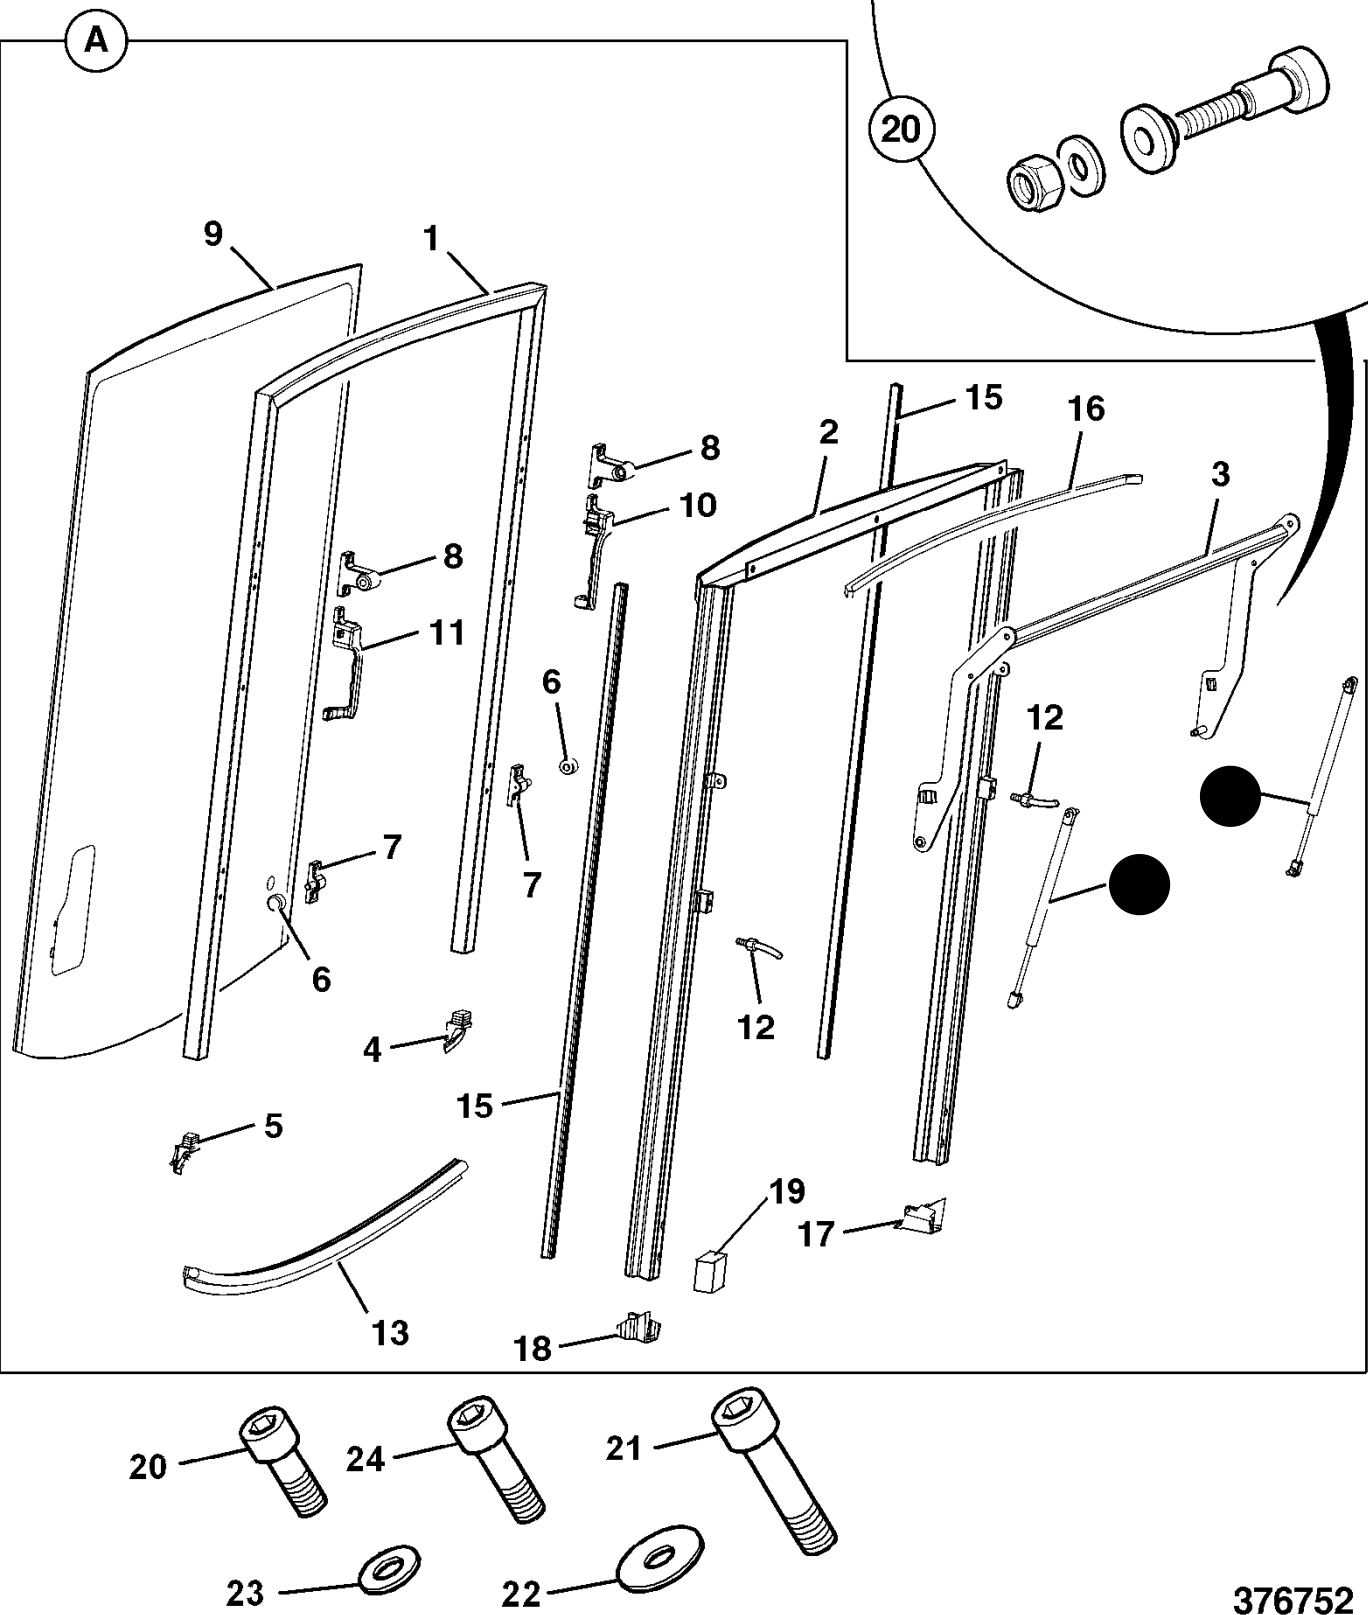
| 3 | :335/03712 | Bar torsion | 1 |
| 4 | :331/28221 | Seal rear window left hand end | 1 |
| 5 | :331/28222 | Seal rear window right hand end | 1 |
| 6 | :331/28223 | Roller Plastic | 2 |
| 7 | :331/28224 | Block roller<br>Supersession > | 2 |
| 8 | :331/28226 | Bracket pivot<br>Supersession > | 2 |
| 10 | :331/28233 | Latch LH | 1 |
| 10A | :331/43562 | Capscrew encapsulated<br>holds 7,8,10 & 11 to frame | 12 |

| 11 | :331/28235 | Latch RH | 1 |
| 12 | :331/28239 | Bar locking<br>Supersession > | 2 |
| 14 | :331/28215 | Strut gas 287 closed, 475 open | 2 |
